**RE: Service Bulletin — Inspection and Replacement of Tempest Spark Plugs, Specific Lots**

**SERVICE BULLETIN SB-012****August 7<sup>th</sup>, 2026**

This Service Bulletin describes a potential cracking problem in specific lot numbers of Tempest<sup>®</sup> Spark Plugs manufactured between May 5, 2026 and July 29, 2026. It recommends immediate inspection of the affected spark plugs prior to your next flight and replacement of any cracked spark plugs. No action is required for Tempest<sup>®</sup> Spark Plugs purchased prior to May 5, 2026.

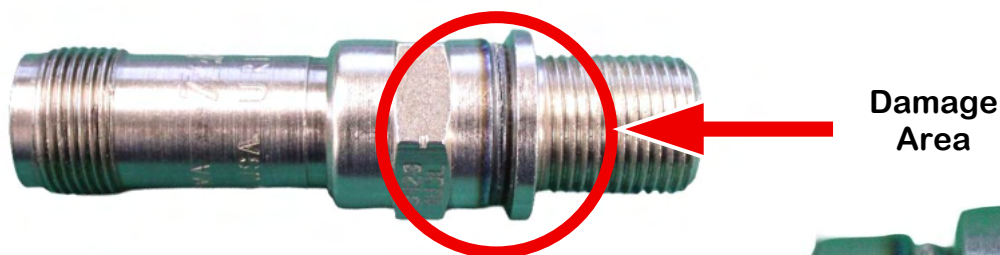
**Figure 1**

There have been limited reports of spark plugs exhibiting cracks. Failure to detect and replace a cracked spark plug could potentially result in damage to the airplane engine and possible loss of power.

There have been field reports of cracks in Tempest<sup>®</sup> spark plugs. The area of damage is shown in Figures 1 & 2.

3. If an affected spark plug is found to be installed, remove the affected spark plug(s) from the engine and visually inspect for cracks as shown in Figures 1 and 2. Similarly, inspect any affected spark plugs in inventory.

5. If cracks are found, replace the spark plug(s). If replacing with new Tempest® spark plug(s), verify the new spark plugs carry compliance stamp SB012 as shown in Figure 4 or are outside the part number and lot numbers listed in Table 1 above.

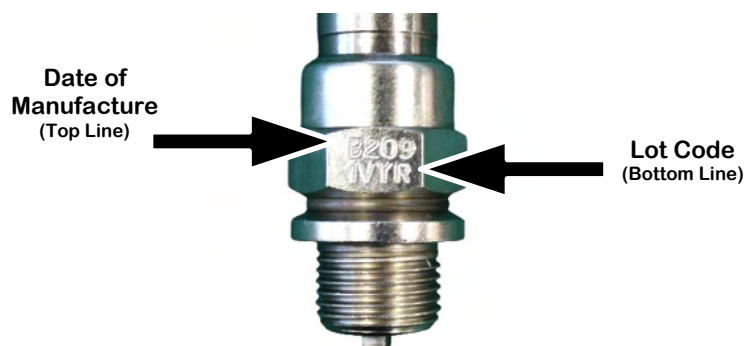
Figure 3

Visually inspect the spark plug for lot code per Figure 3. The lot code is stamped on the hex of the spark plug body as shown. Compare the stamped lot code to the affected part numbers and lot numbers listed in Table 1. Physical inspection of spark plugs is required. Remove from engine as required to confirm part number a lot code.
